Manhole Inspection Summary

Manhole # S19GG_003MH

Insp Date: **6/13/07 10:04 AM**

Location Address: **1618 PULASKI ST**

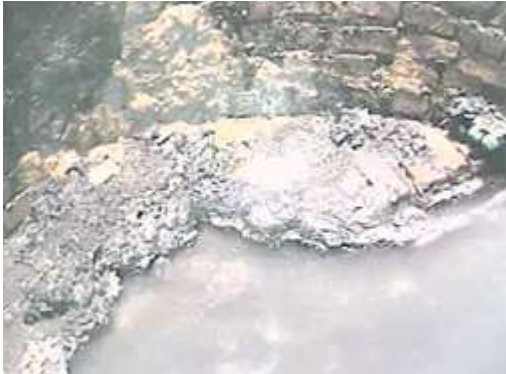
Defect 6

Condition: ☐ Sound ☐ Cracked ☐ Root Intrusion ☐ Deteriorated ☐ Leaks ☒ **Debris**

DEBRIS ON BENCH AT 9 OCLOCK - GREASE

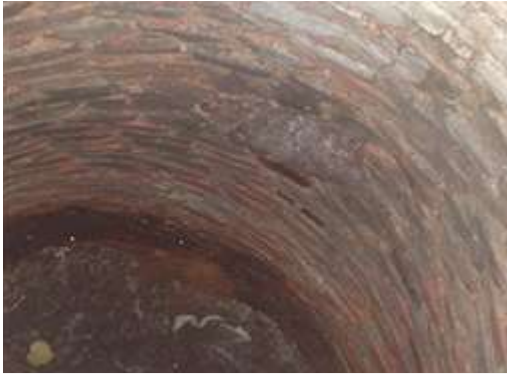
Defect 4

Condition: ☐ Sound ☐ Cracked ☐ Root Intrusion ☐ Loose Brick ☒ **Deteriorated**

DETERIORATION OF BARREL

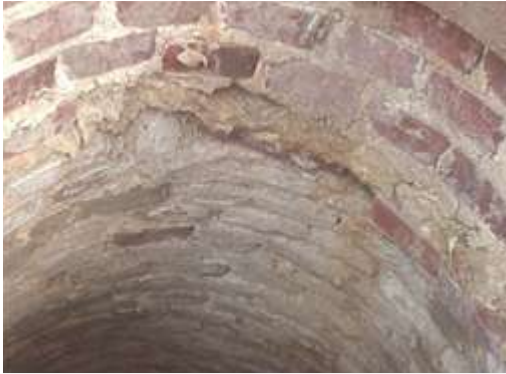
Defect 3

Condition: ☐ Sound ☐ Cracked ☐ Root Intrusion ☐ Loose Brick ☒ **Deteriorated**

DETERIORATION OF CORBEL

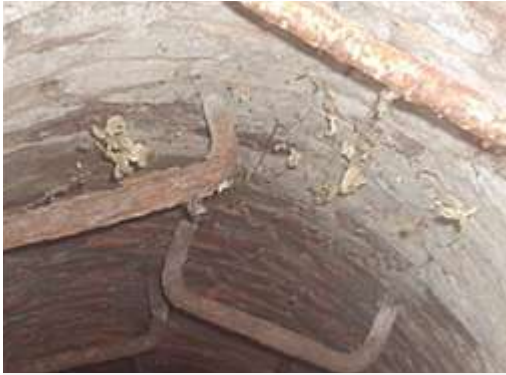
Defect 2

Count: **6** Missing: **0** ☒ **Corroded**

CORRODED STEPS

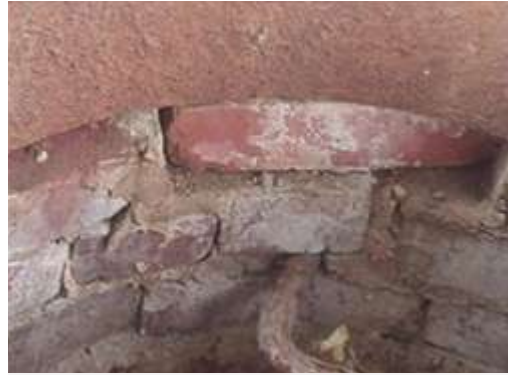
Defect 1

Condition: ☐ Sound ☐ Cracked ☐ Root Intrusion ☒ **Loose Brick** ☐ Deteriorated

LOOSE CHIMNEY BRICKS

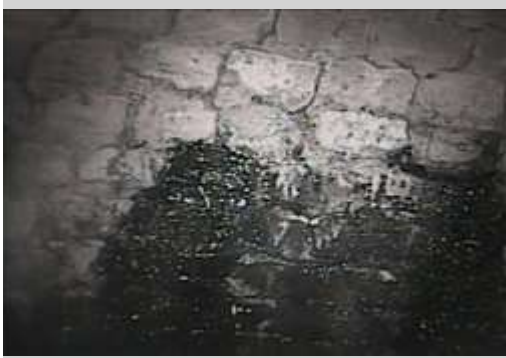
Defect 5

Infiltration: ☐ None ☐ Joint ☐ Cracks ☐ Mortar ☐ Roots ☒ **Wall**

INFILTRATION OF BARREL

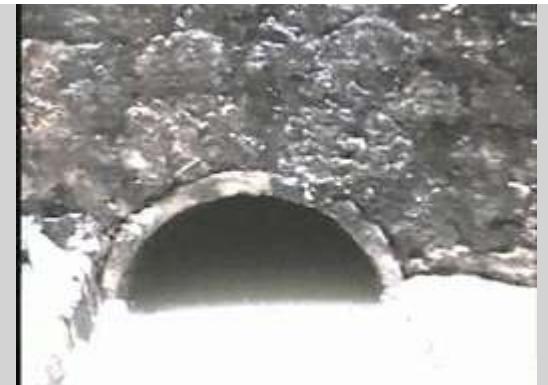
6 O'Clock Inflow

Pipe Height: **15.6** (in.) Rod and Bar (Angled)
Pipe Material: **Clay** ☐ Pipe Lined
Invert Depth: **12.42** (ft.) Flow Characteristics: **Slow**
Deposits: ☐ None ☐ Mud ☐ Sludge ☐ Debris ☒ Grease
Silt Depth: **3** (in.) Deposits Extent: **Medium**
Infiltration: **None** Pipe Seal Cond: **Sound**

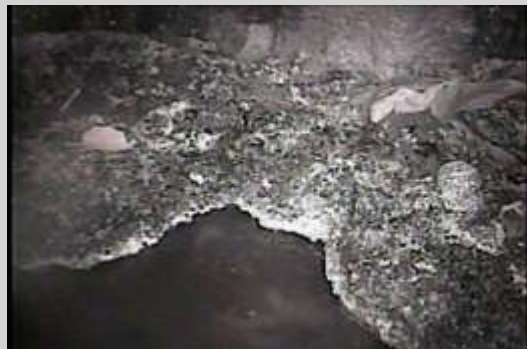
9 O'Clock Inflow

Deposits: ☐ None ☐ Mud ☐ Sludge ☐ Debris ☒ **Grease**

Silt Depth: **8** (in.) Deposits Extent: **Heavy**
